PERATION

GREENHOUSE

SCIENTIFIC DIRECTOR'S REPORT

ANNEX 3.2 U. S. NAVY STRUCTURES

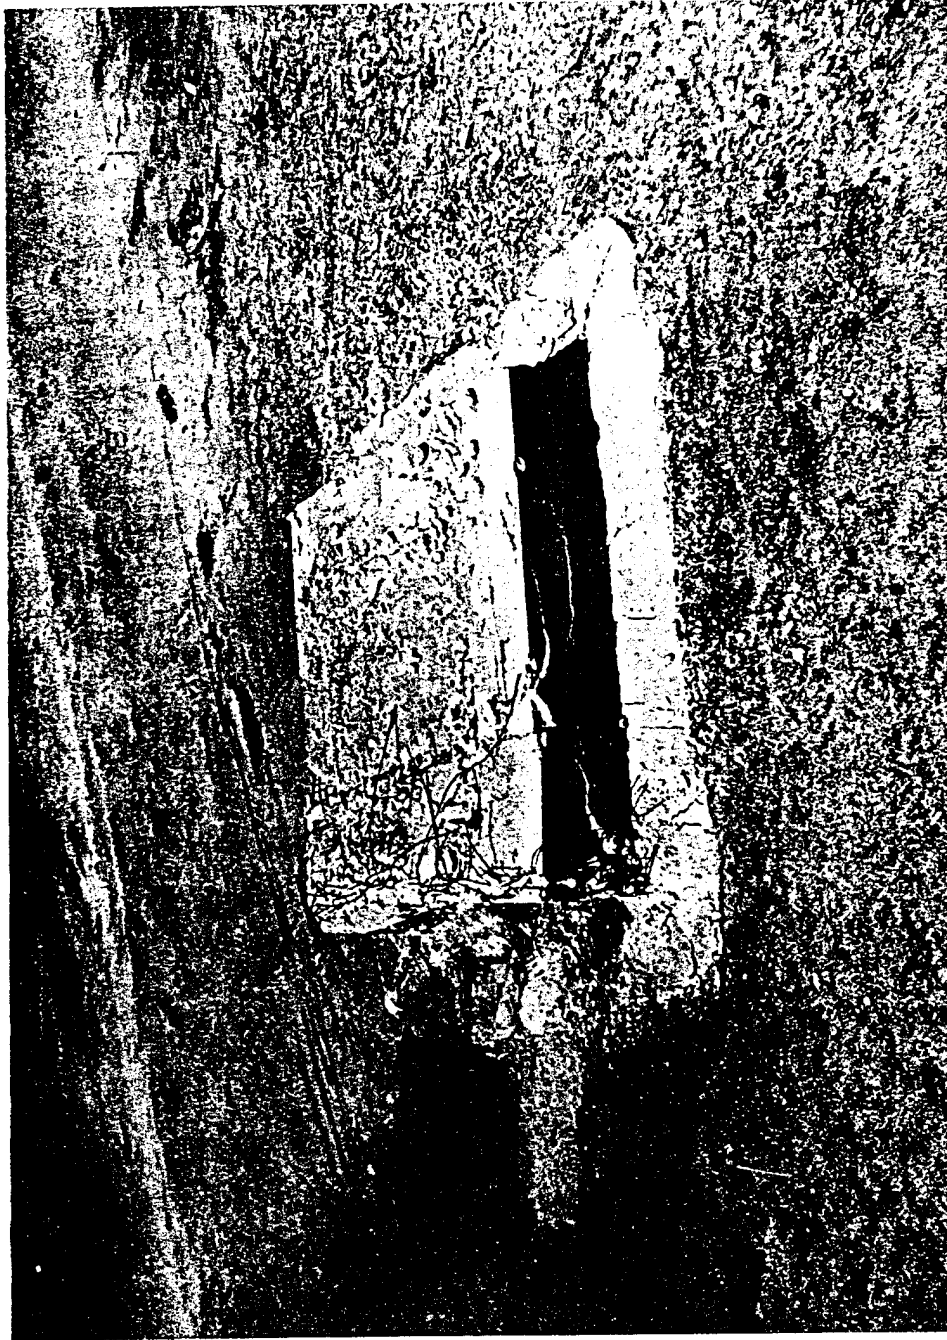
Fig. L.1 Post-shot Aerial View, Structure 3.2.1a

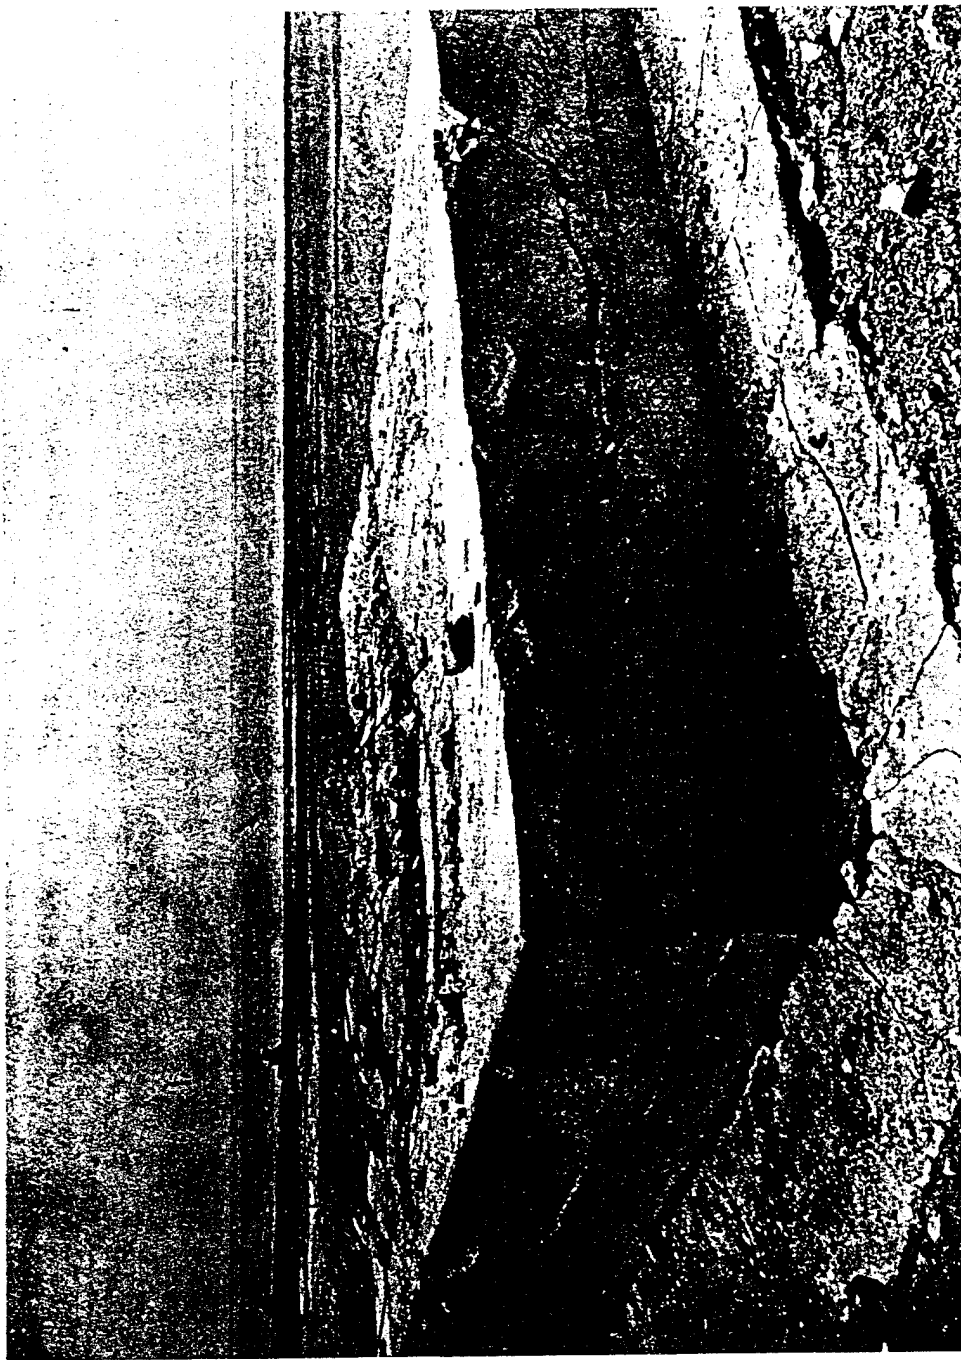
Fig. L.2 Roof Slab from Rear Showing 13-in. Dishing, Structure 3.2.1a

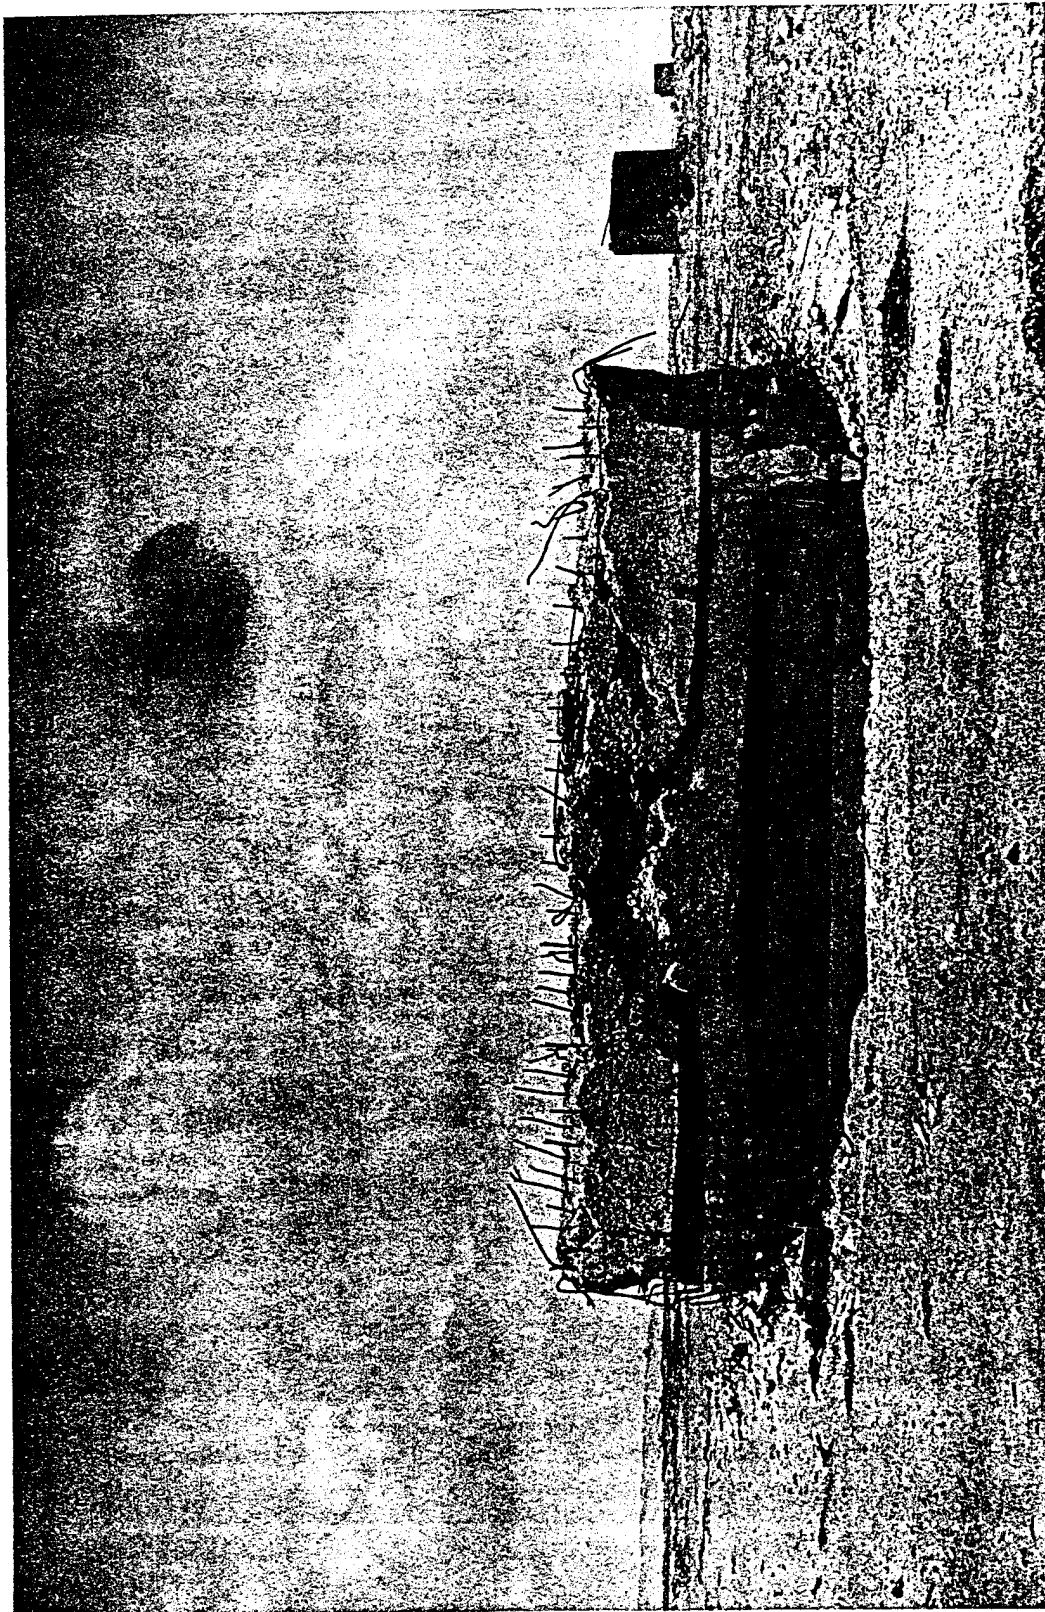
Fig. L.3 View Normal to Front Wall, Structure 3.2.1a

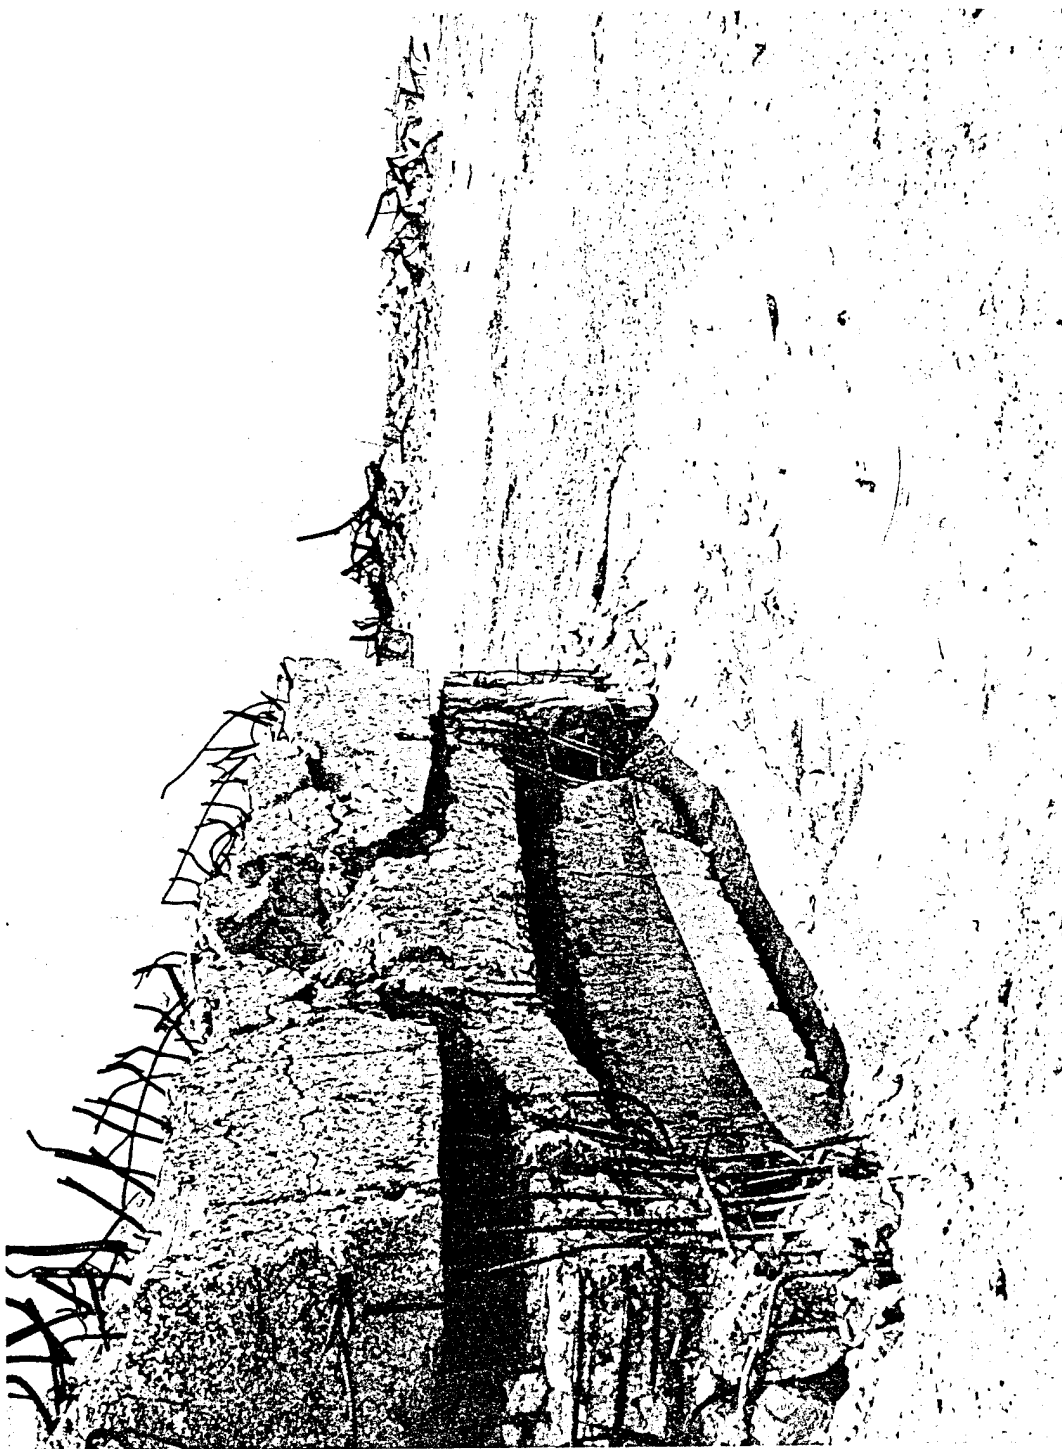
Fig. L.4 Deformed Front Bearing Wall and Slab Edge, Structure 3.2.1a

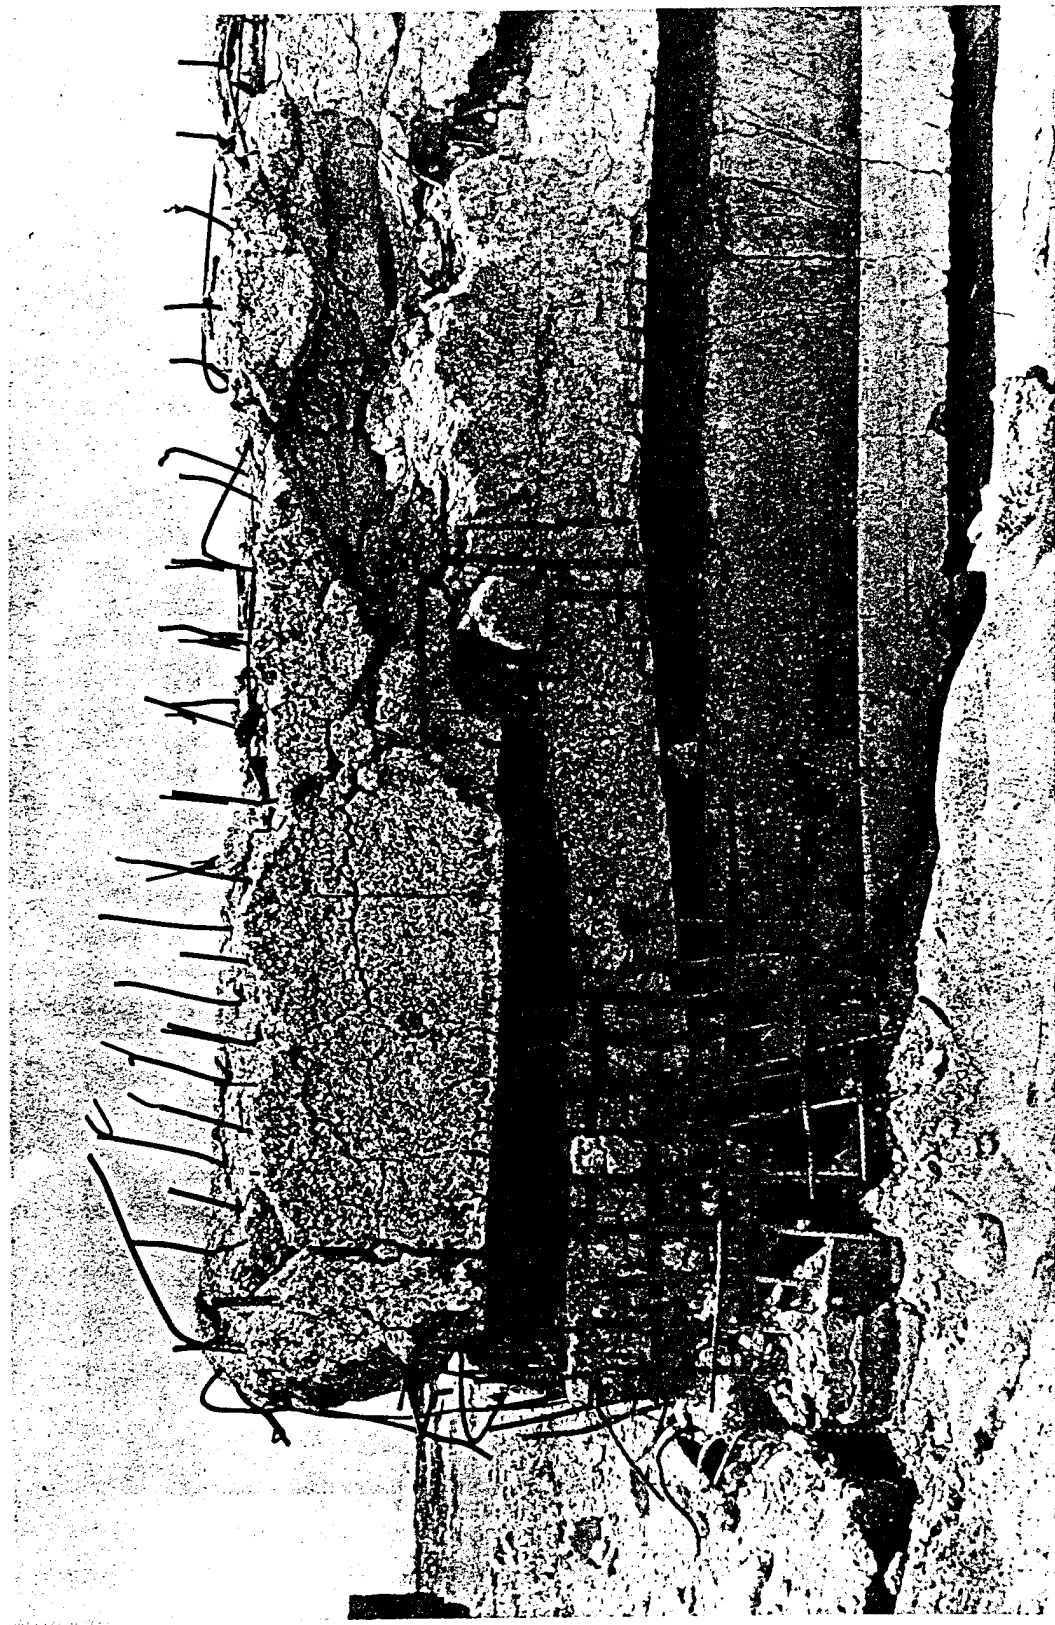
Fig. L.5 Left End Front Wall, Structure 3.2.1a

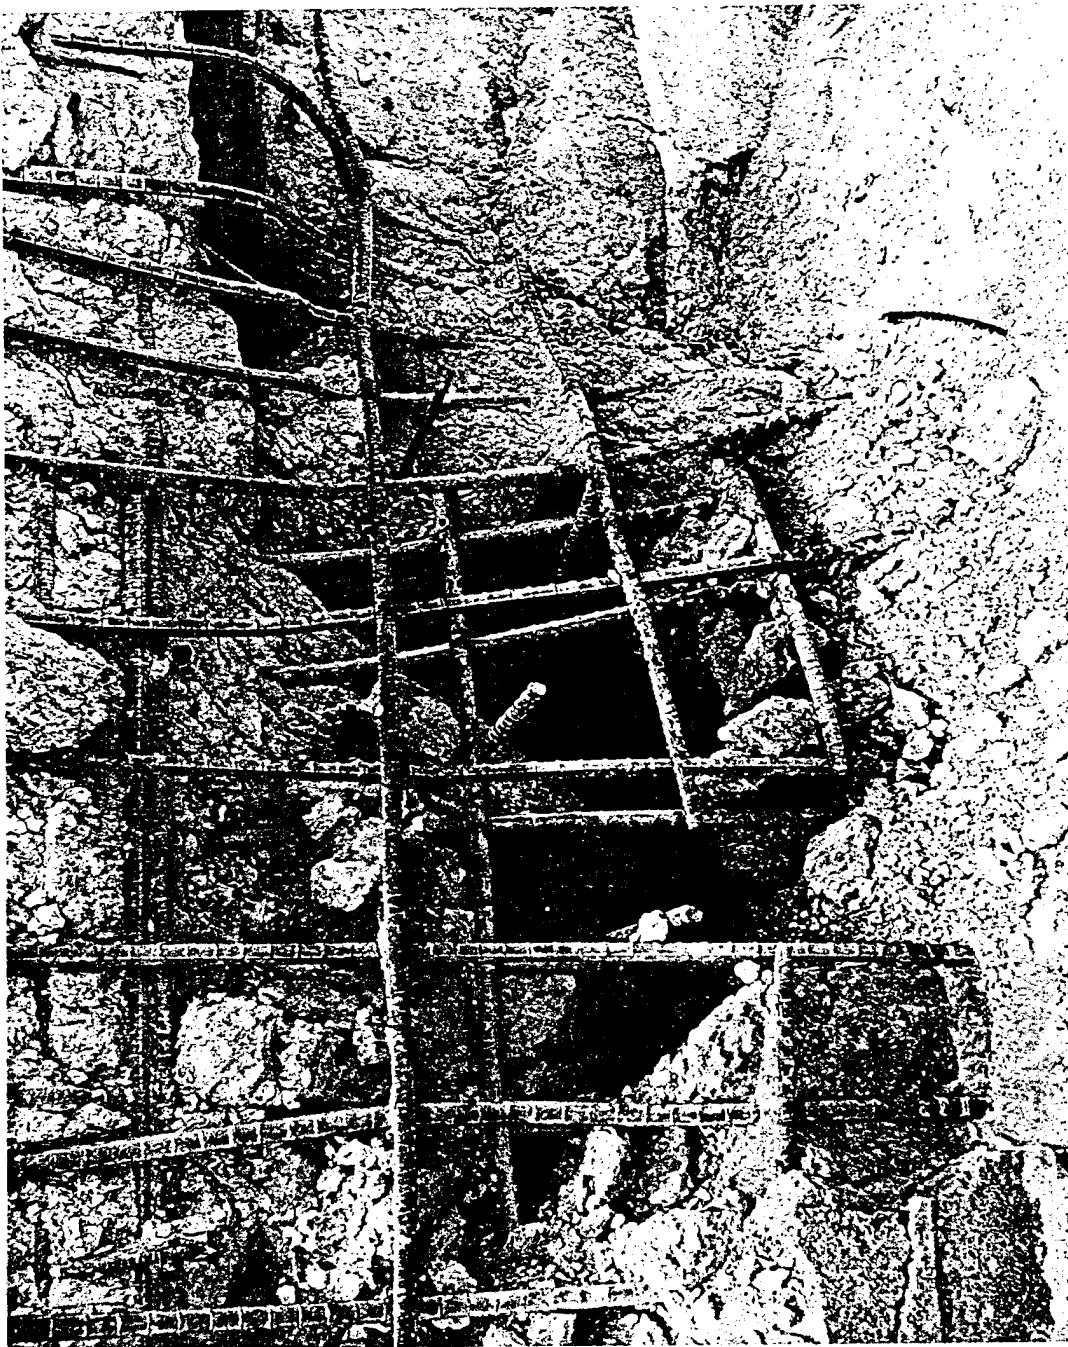
Fig. L.6 Close-up of Front Left Corner, Structure 3.2.1a

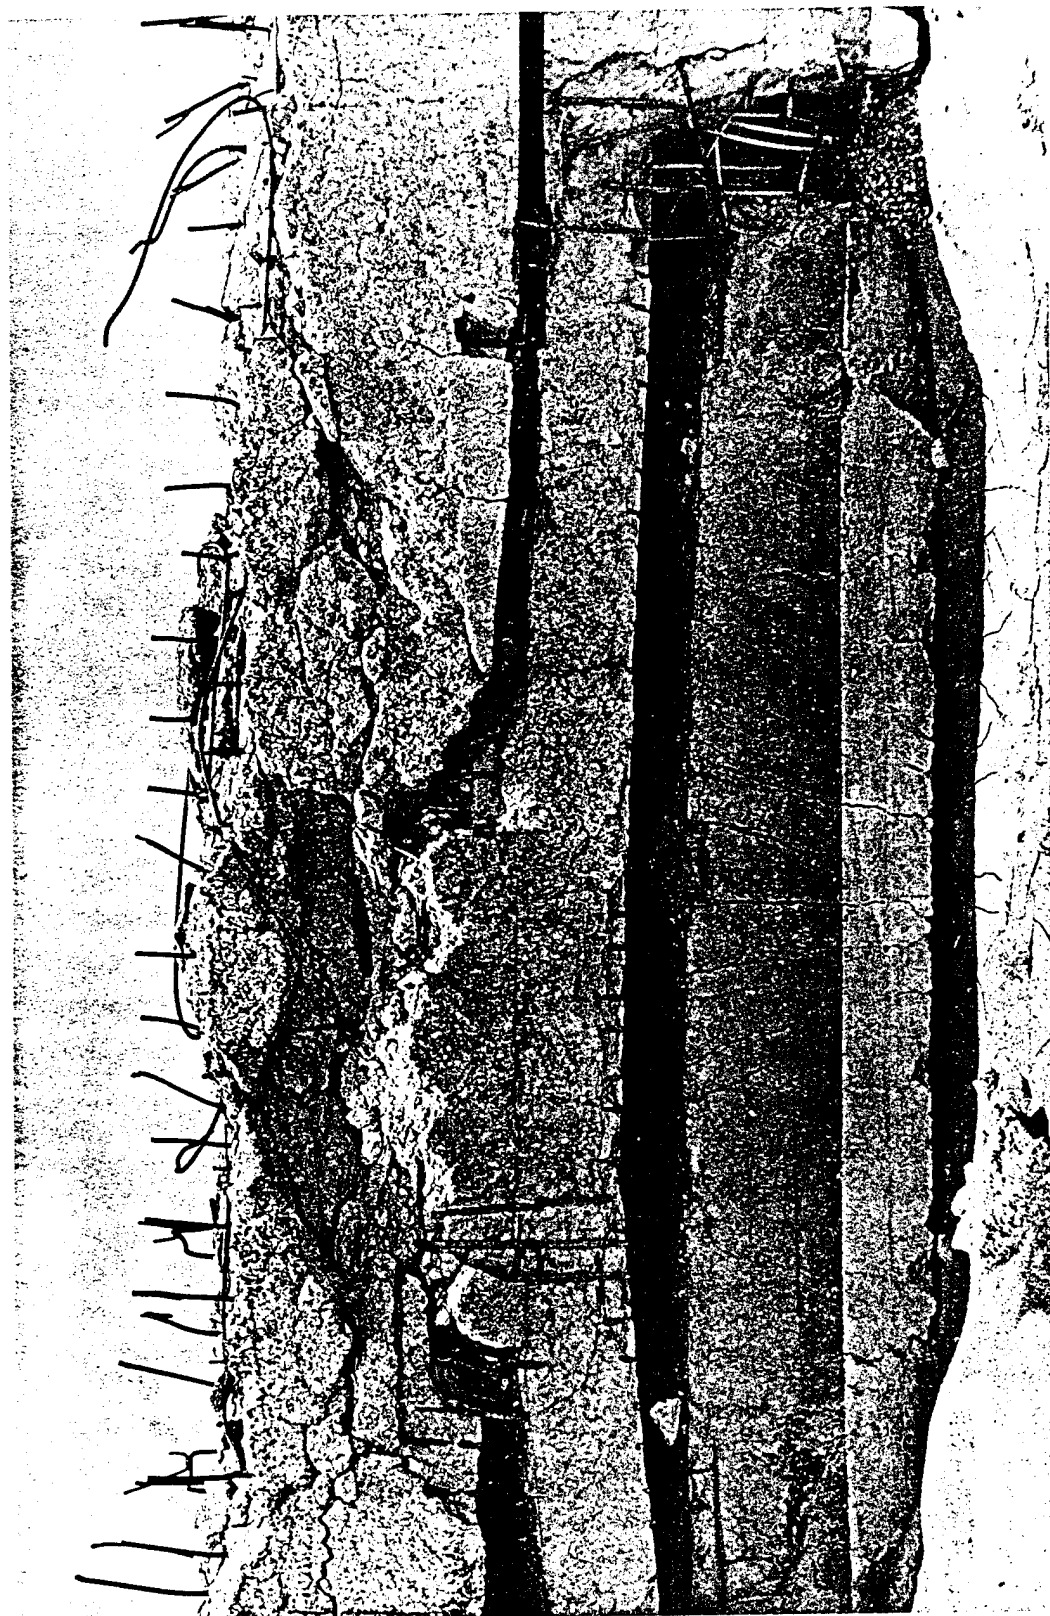
Fig. L.7 Center Section of Front Wall, Structure 3.2.1a

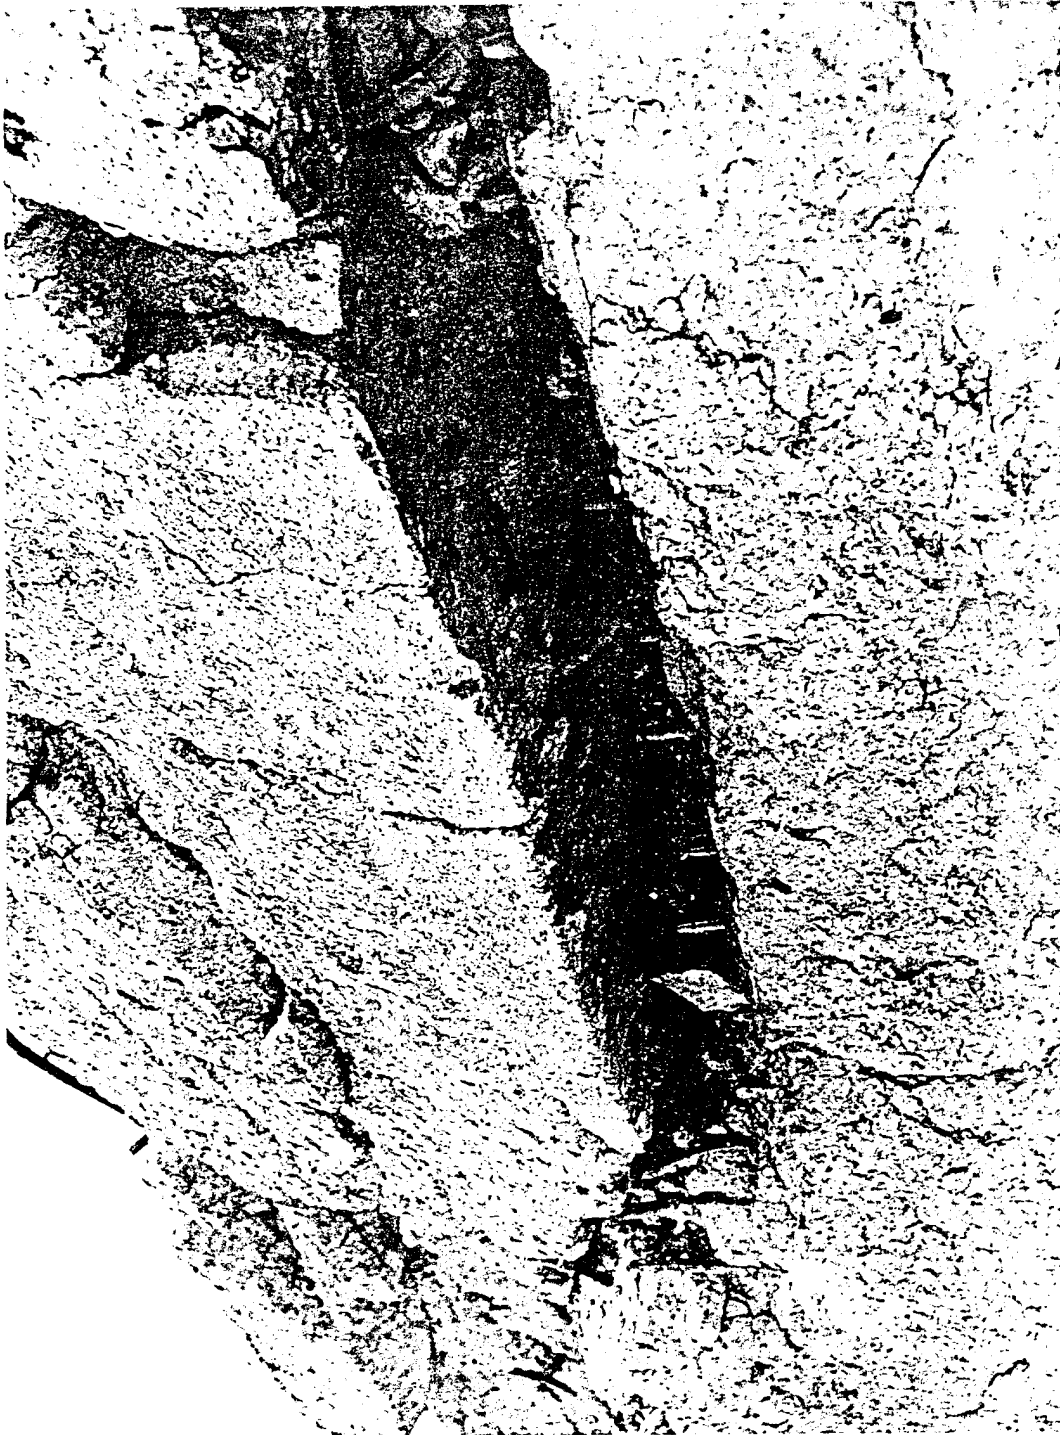
Fig. L.8 Opening in Front Edge of Roof Slab at Construction Joint Showing Dowel Failures, Structure 3.2.1a

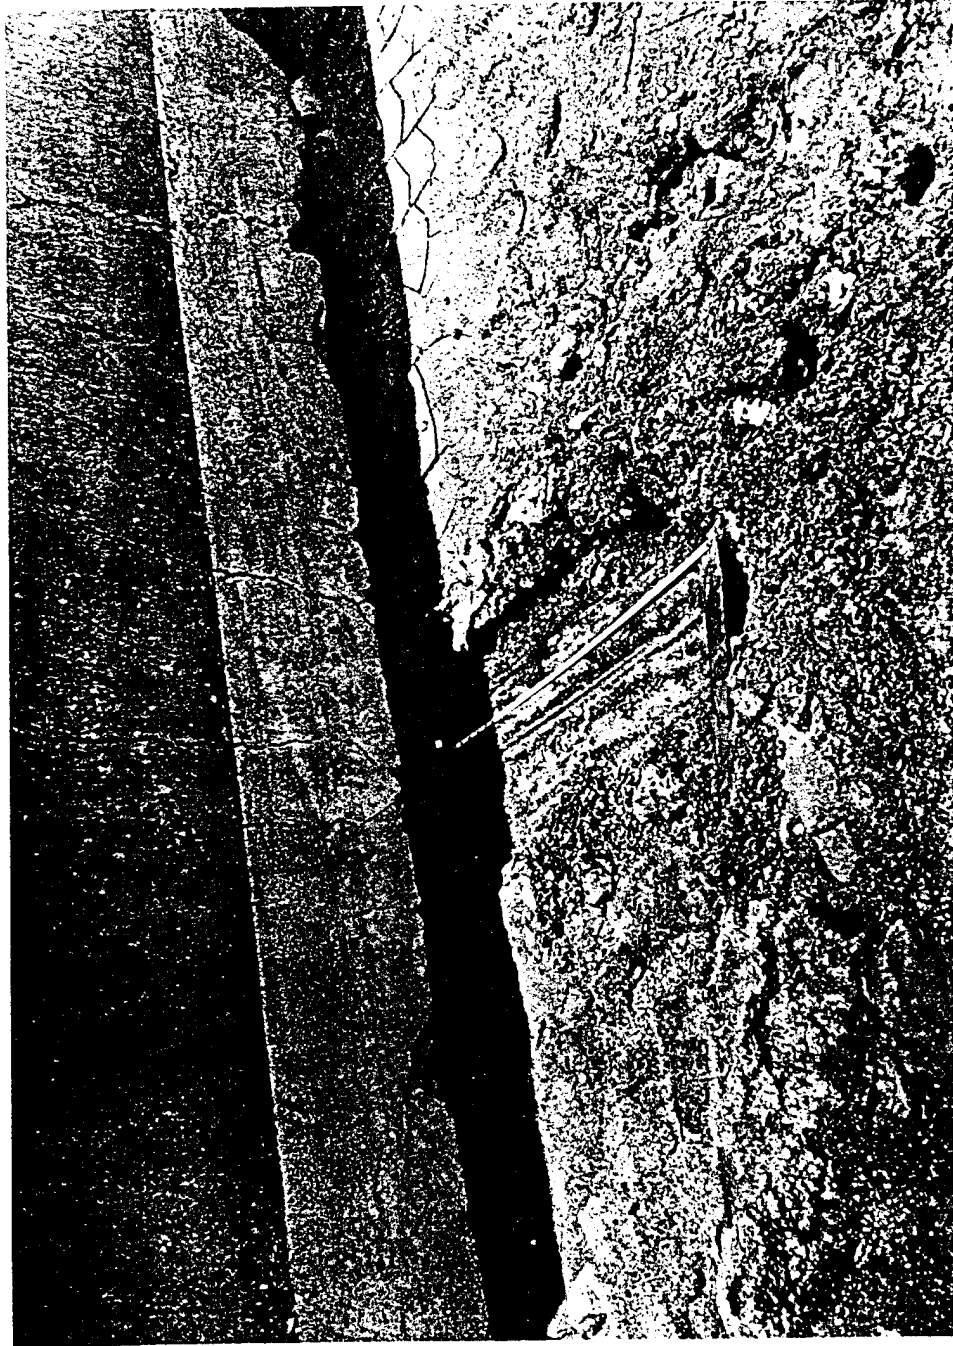
Fig. L.9 Close-up of Top Surface of Footing Slab at Center of Front Wall Showing Front Wall Deflection of 2½ ft,
Structure 3.2.1a

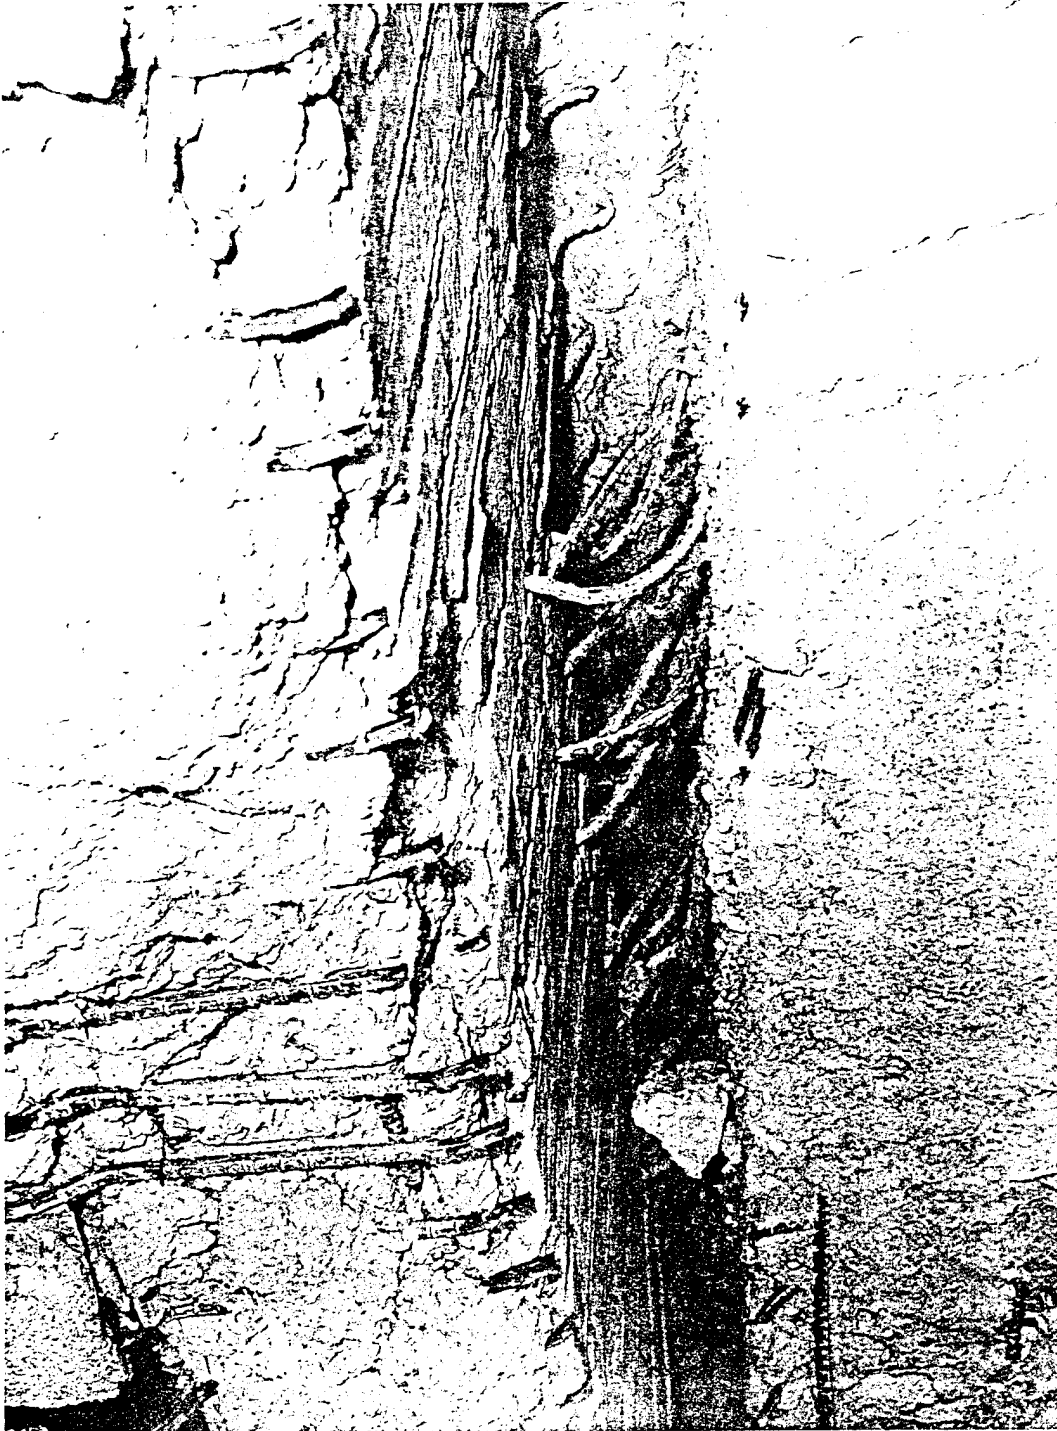
Fig. L.10 Undersurface of Roof Slab at Left Front Showing Dowel Scratches and Bottom of Shear Plane,
Structure 3.2.1a

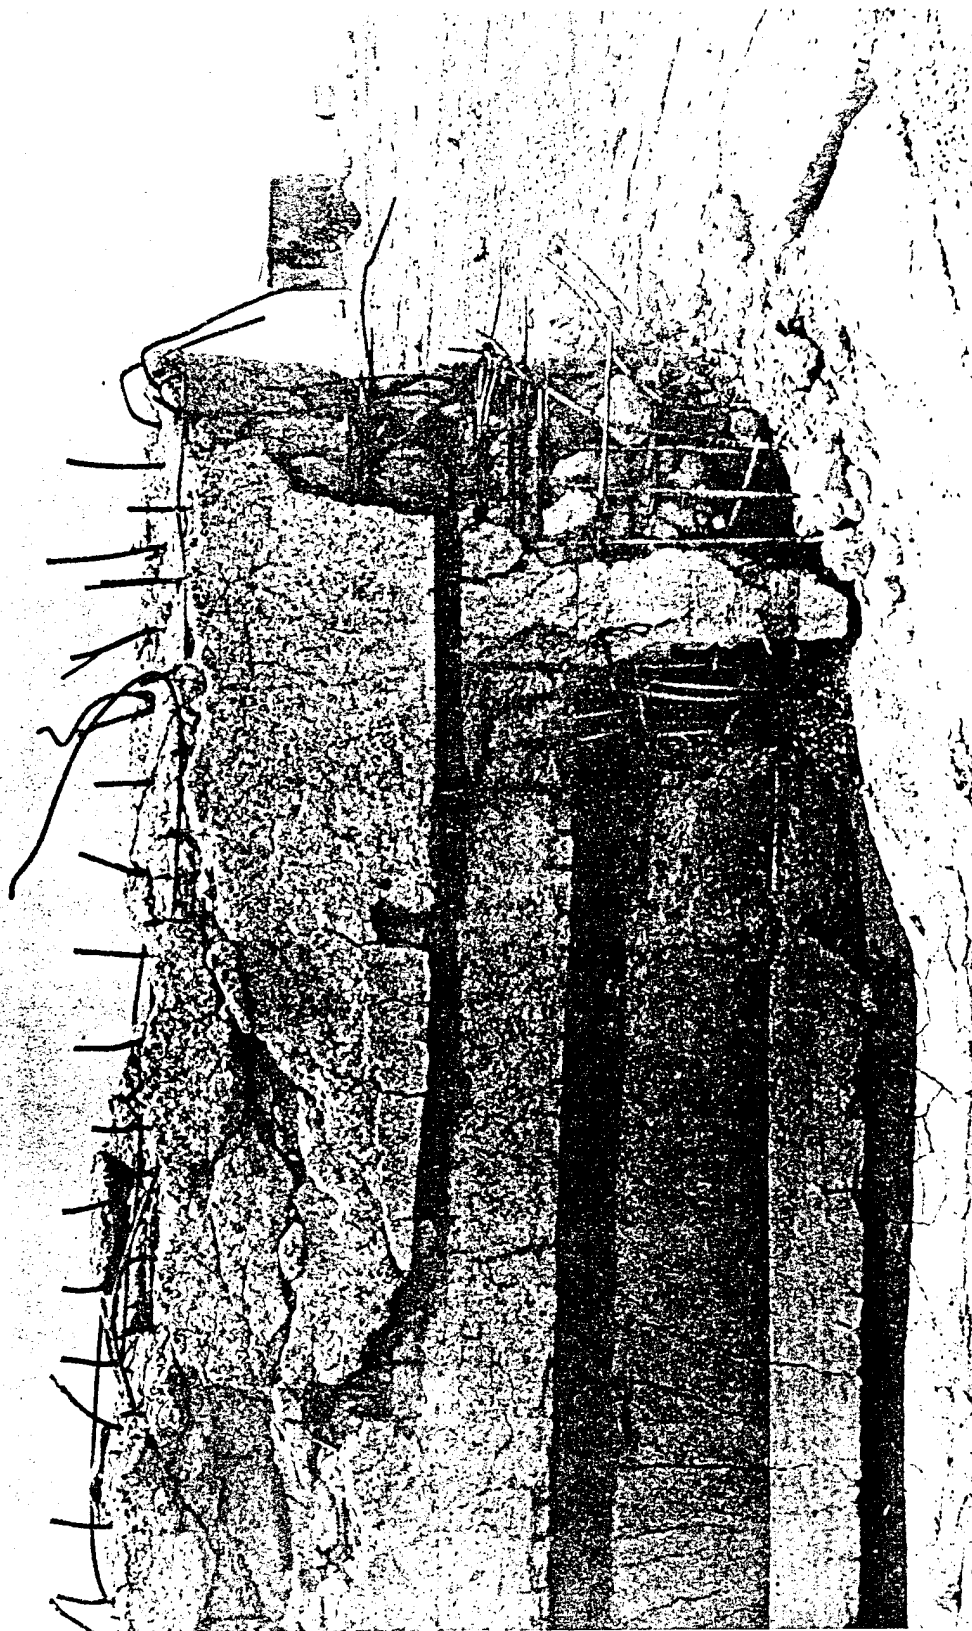
Fig. L.12 Right Front Corner from Front, Structure 3.2.1a

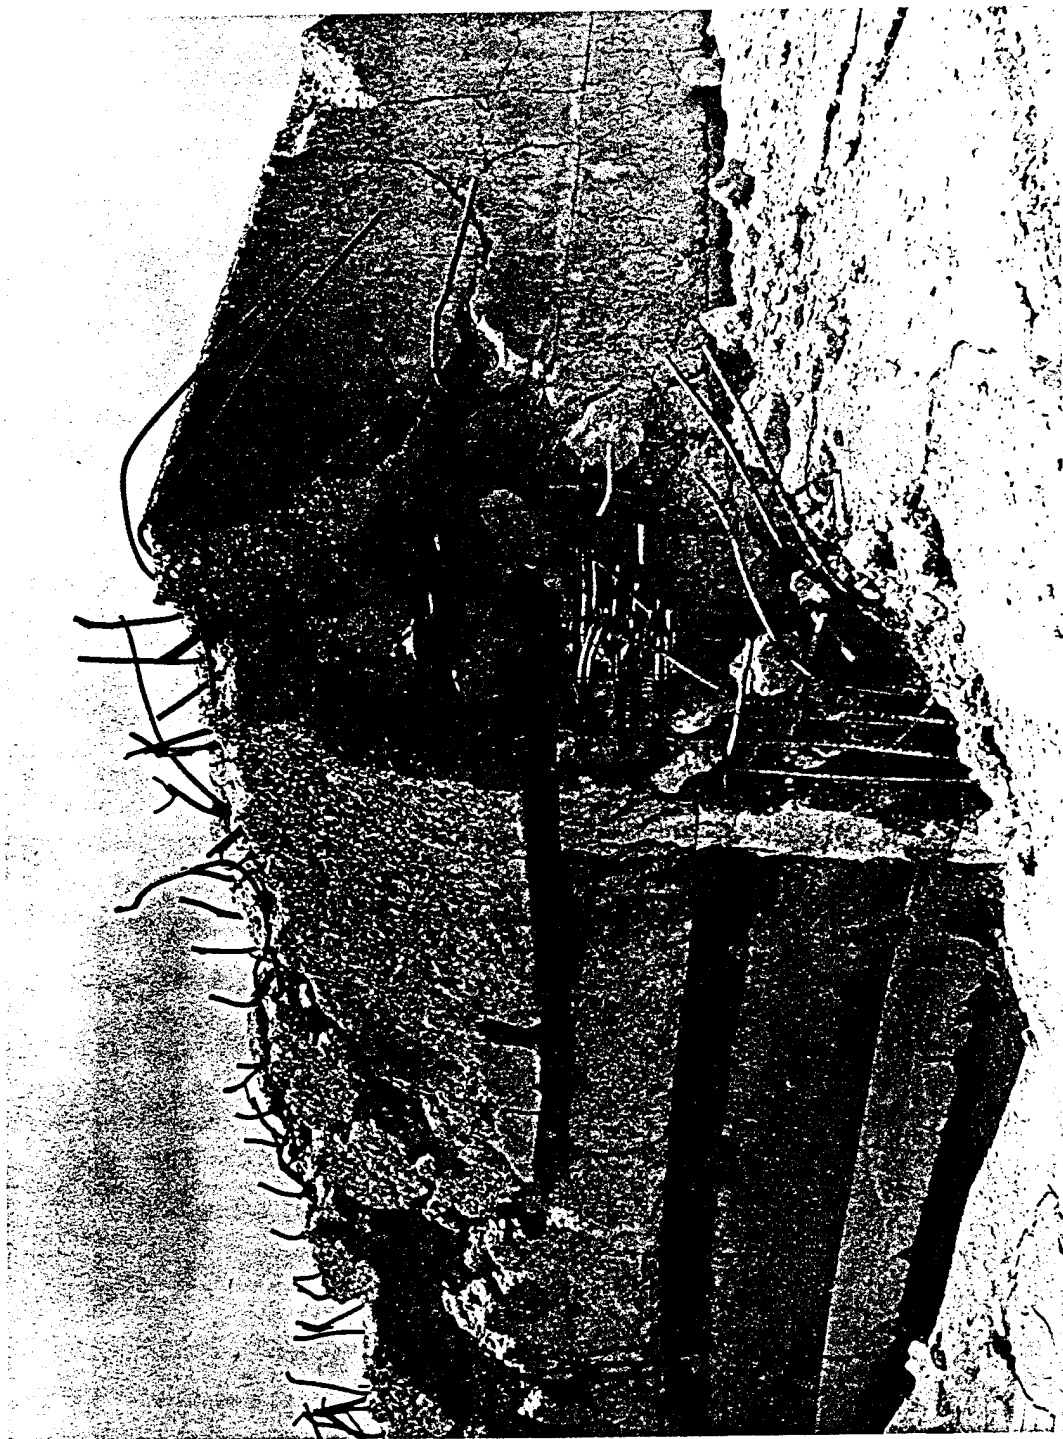
Fig. L.13 Right Front Corner from Side, Structure 3.2.1a

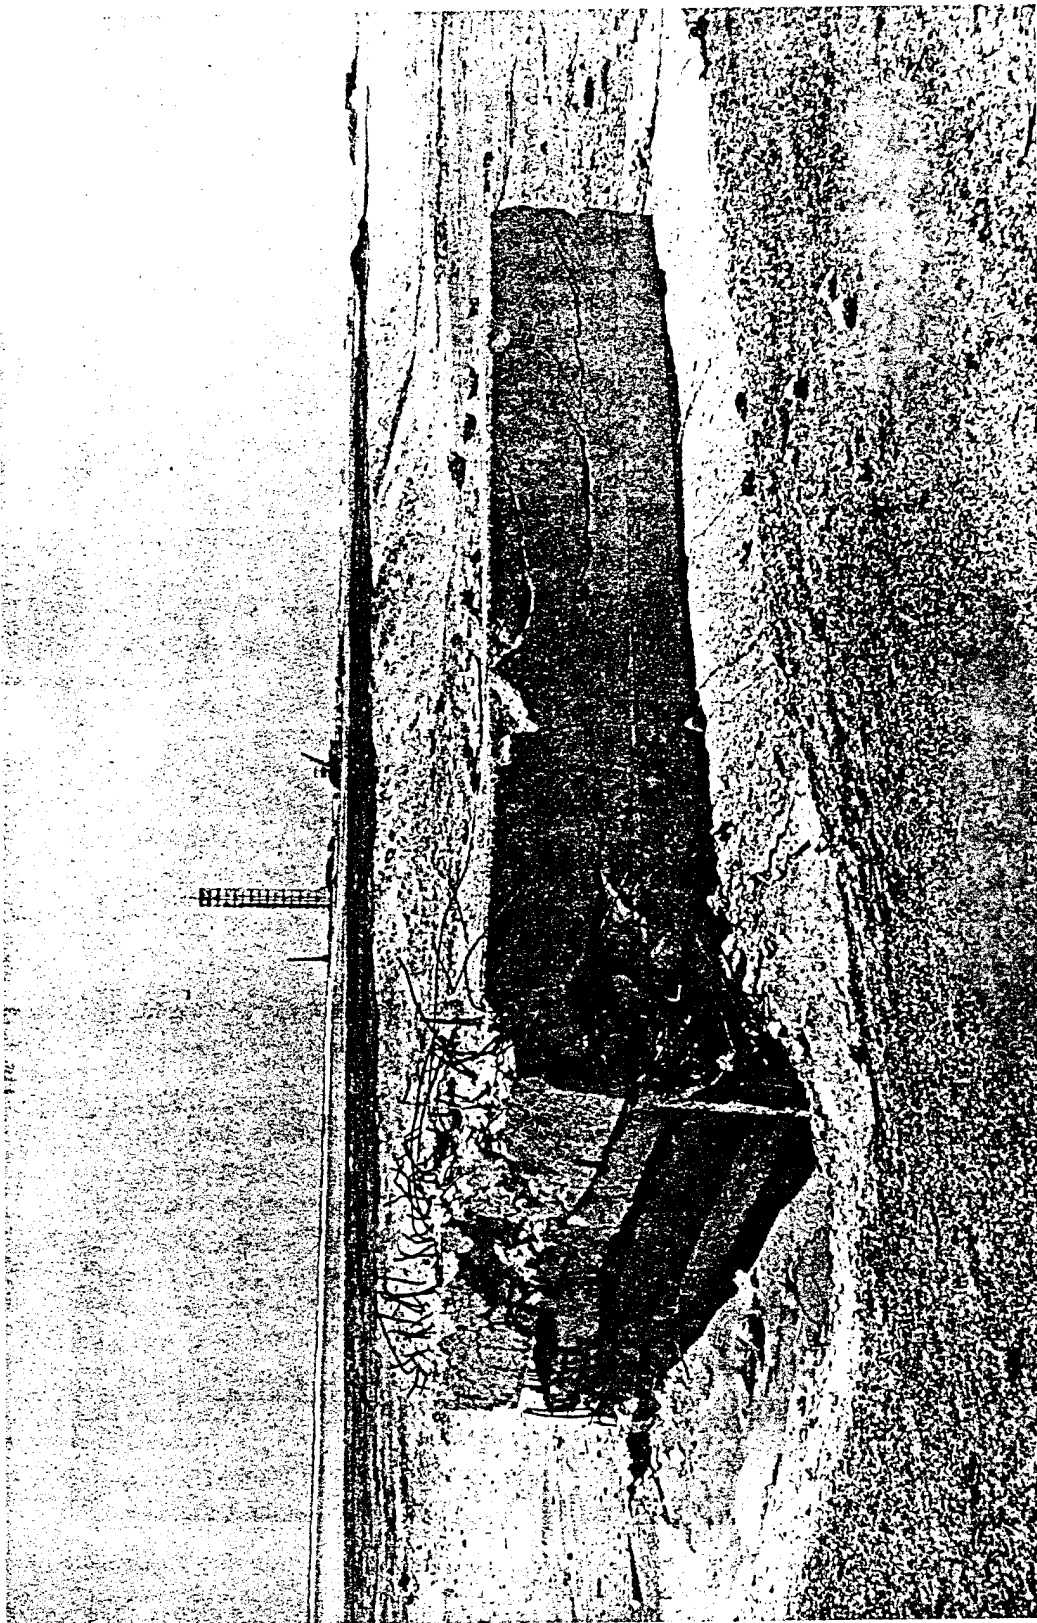
Fig. L.14 General View of Roof from Right Front, Structure 3.2.1a

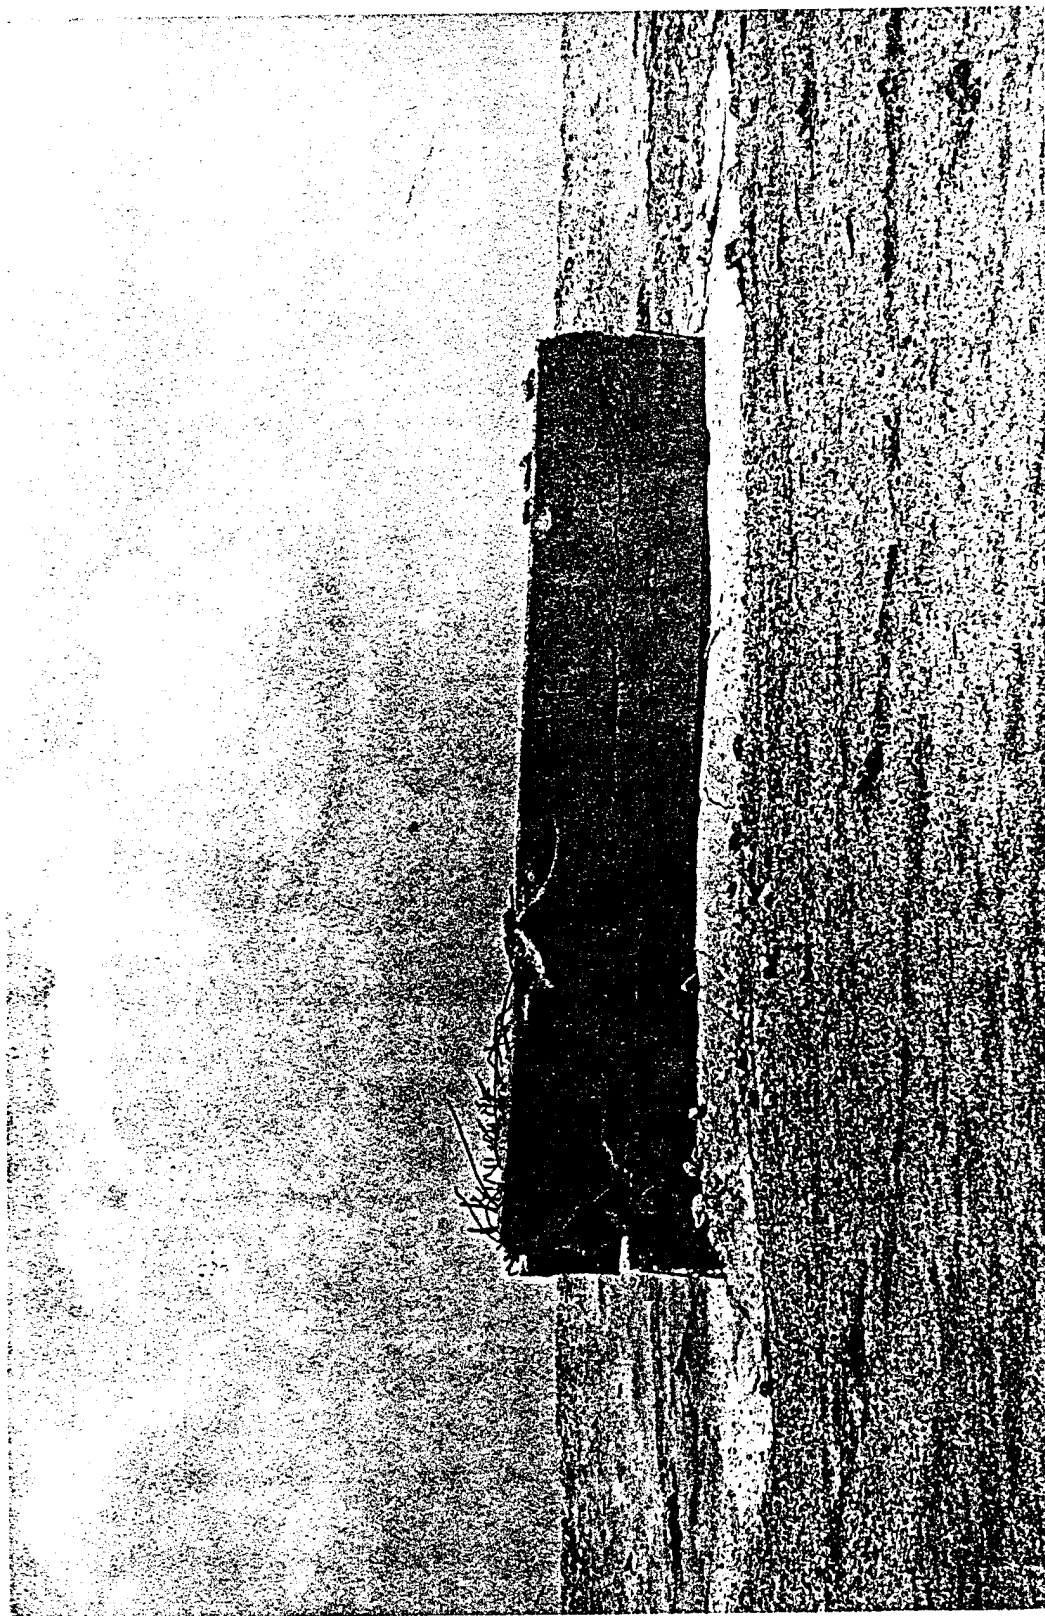
Fig. L.15 General View of Right Side, Structure 3.2.1a

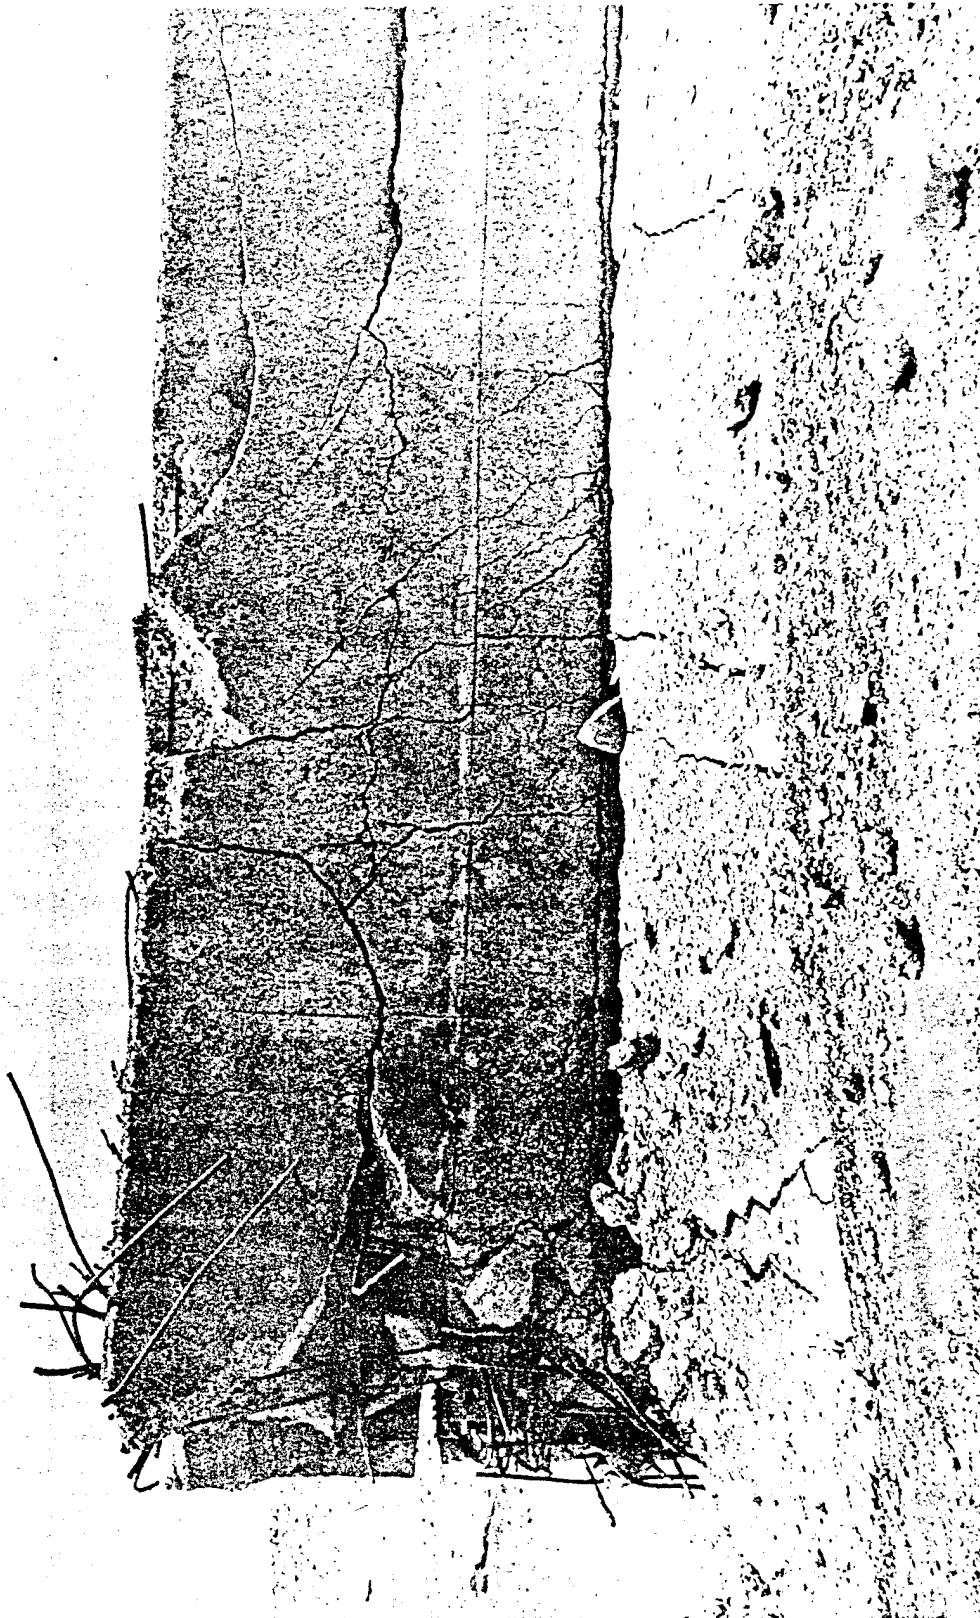
Fig. L.16 Left End of Right Edge of Slab, Structure 3.2.1a
